Top of the South Model A Club Inc.

November – December 2024 Newsletter

Model A Shock Absorbers - Part 3

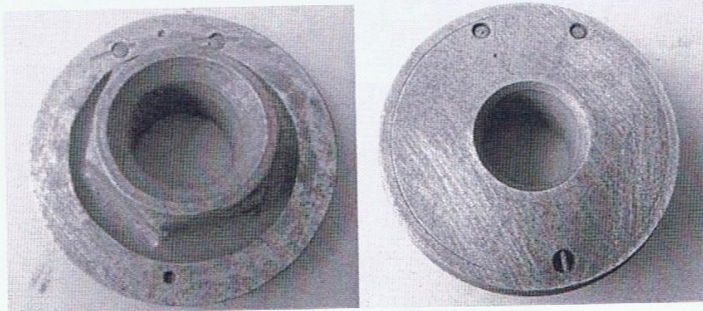
- a. Restoration of the check valve in the nut bushing (see the drawing in Part 1 in the October 2012 issue). The nut bushing as shown in the two photographs below will be called the inner cap in this article.

The purpose of the check valve, which in the photographs is located at the lower part of the inner cap, is to allow replenishment of oil from the outer chamber to the inner chamber but prevents oil from being ejected from the inner chamber when the shock is operated. It can be tested for how well it blocks flow in the reverse direction by holding the inner cap horizontal and upside down such that the check valve ball bearing is sitting on its seat. Put a drop of thin oil onto the top opening to the check valve and see if the oil weeps through. If so the ball bearing and/or its seat is pitted with rust or it is clogged with debris and must be refurbished.

There are two air vent plugs located at the top of the inner cap and visible in both photos. Hold the inner cap upside down and put a drop of thin oil in the inner recesses of the vent plugs (see top photo) and see if oil leaks through the plugs. If not drive the plugs out from the inner side of the cap and clean the very fine channel cut lengthwise along each plug. Then reinsert the plugs and test again that oil flows freely.

In the bottom photo there will be seen a very small indent mark located midway between the two vent plugs. When the inner cap is screwed in very tightly this indent must be at the very top of the shock body so that each vent plug is then able to allow air to vent from its respective half of the inner chamber. If the small indent mark does not align properly then it is possible that the inner cap may have during its life been put in the wrong shock body. It is not recommended that the inner cap be machined to correct misalignment as it is too difficult to align accurately in a lathe and also the check valve retaining pin could be machined away if too much metal is removed. It is better to remove the air vent plugs, weld up the holes and relocate the plugs to their required location. However make sure that the check valve is still towards the bottom region of the shock body otherwise it will not function properly and therefore may also need to be relocated.

The check valve is held in place by a retaining pin which is difficult to drill out accurately. Therefore drill part of the pin

away from the inside of the inner cap. The outer part of the retaining pin is then able to be driven in further and again a drill is used to remove more of the pin. Repeated several times the outer part of the pin can be removed completely. A 5/64 inch drill is then inserted into the hole left by the top part of the pin so that the remainder of the pin can then be drilled out. The check valve is restored by cleaning the internal ball bearing seat with a drill, replacing the ball bearing with a new one and installing a new retaining pin.
