Top of the South Model A Club Inc.

September / October 2024 Newsletter.

Model A Shock Absorbers - Part 2

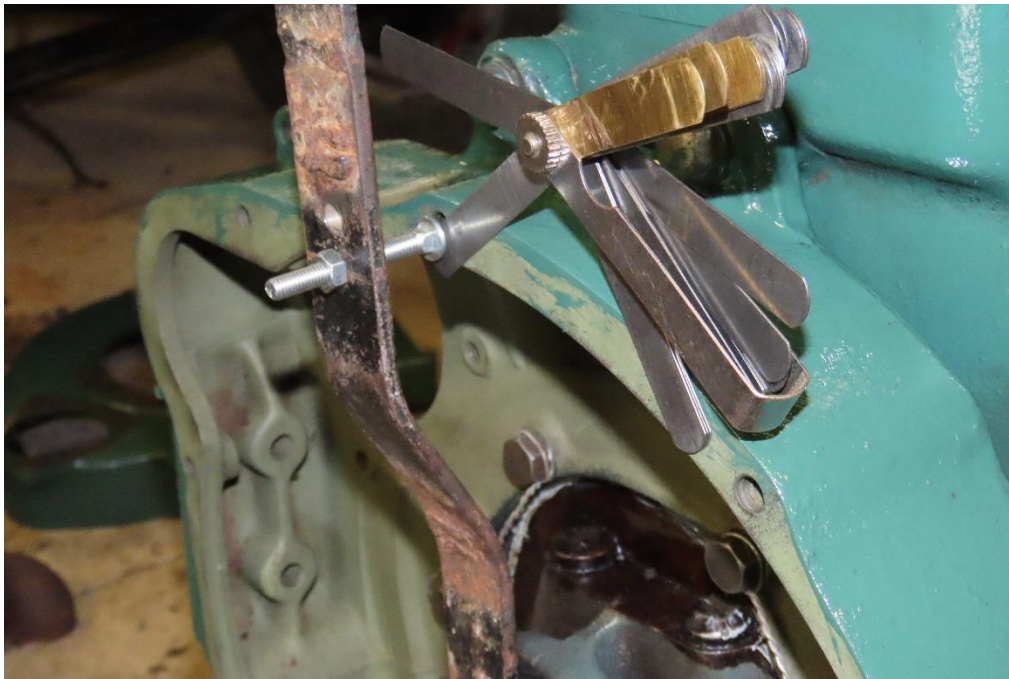
Measuring device bar bolted to crank flange. Check all around the rear face of the housing using feeler gauge. 6 thous deviation is the max .

While on the run back from Kaikoura I started to notice a knock in the old A which I decided was probably a big end starting to fail. So out with the motor and it sure was the case. New bearing fitted and all sorted, however I also decided to check a possible vibration problem which turned out to be a distortion in the flywheel housing. The max for this is about 6 thous. I found it to be out of line with the crank shaft flange by 12 thous so ended up fitting another housing which brought things back in line.

I also checked the flywheel for wobble. The max permissible deviation is 5 thous. Mine was found to have about a 10 thous wobble which was also corrected and finished with about 2 thous. For accuracy in this case I used a DTI reading off the flywheel face. These issues can create problems in the gear box, primarily causing a problem with jumping out of gear, especially in second.

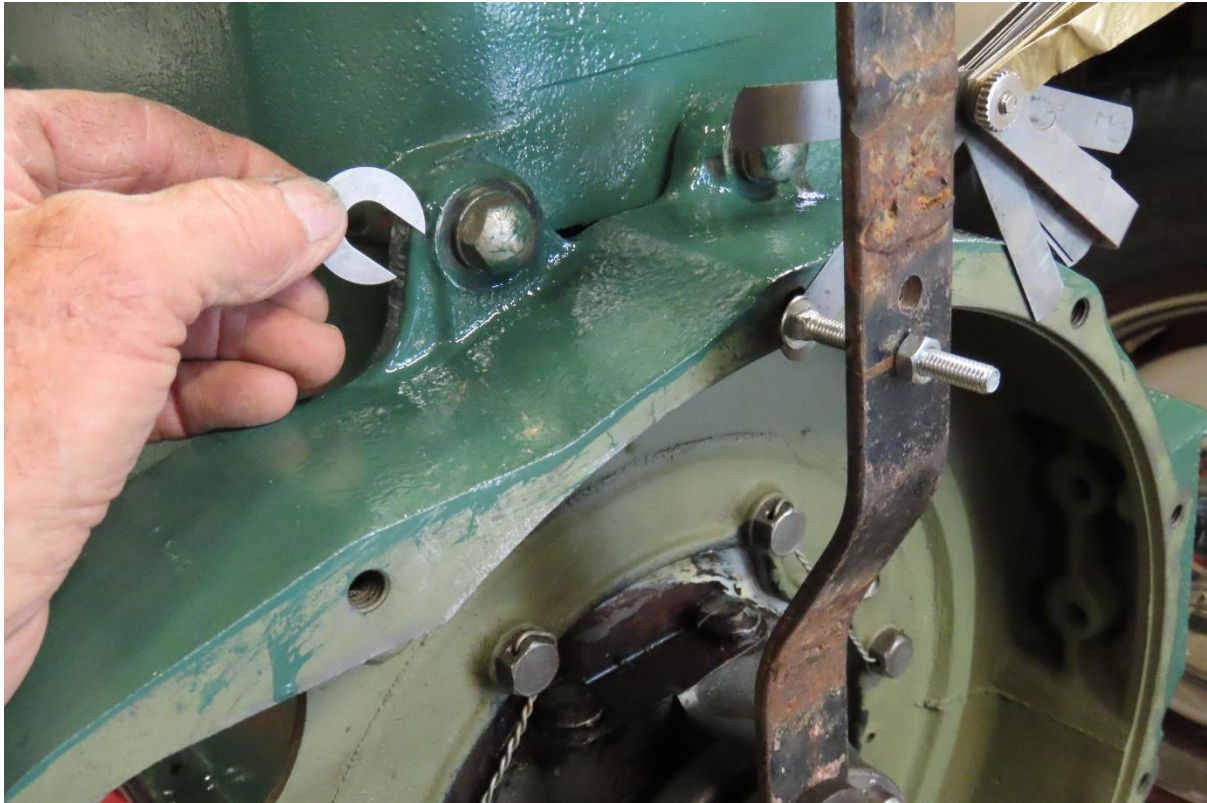
Shims that go between block and flywheel housing. Standard size is 10 thous. Some variation may be required to bring assembly into correct alignment.

Regarding the flywheel housing a very important consideration is the possibility of the required shims not being in place at the two top mounting bolts. These are required to compensate for the thickness of the gasket fitted between the block and the housing. Very important consideration with respect to ensuring proper alignment between the motor and gear box. Plenty of info available regarding the aspect which sometimes overlooked during engine assembly.

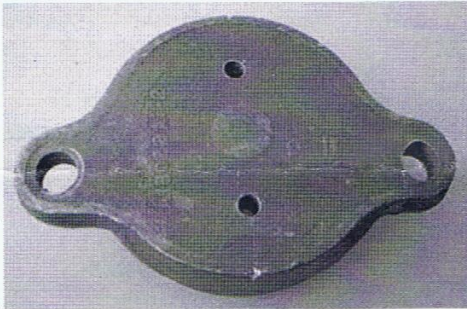
The partition can be removed by drilling two holes in the back of the shock body as shown in the photograph. These holes are marked out on the centreline of the partition and approximately 3/4 inch from the edge. Drill these holes 7/32 inch in diameter and slightly longer than the thickness of the shock body base. A pin punch is then used to drive the partition out of the shock body. The holes made will need to be filled later and this can be done by threading the holes and inserting threaded studs which can be locked in place with retaining fluid such as Locktite.

Note regarding Part 2: The following applies only to the restoration of the check valves within the shock body centre partition as shown in the photographs below. There is also a check valve in the nut bushing (see the drawing in Part 1.) also but its restoration and testing will be discussed in Part 3.

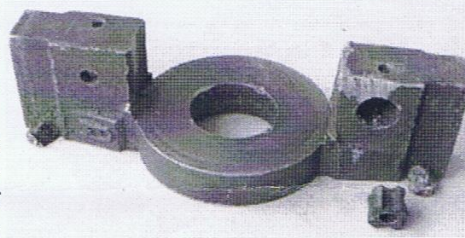
contains a small nozzle having 4 outer grooves for oil flow and it is held in place by the retaining pin. (See the second photograph where a nozzle has been extracted) A 2.5 mm drill is entered **Centre Partition** into the centre of the nozzle and the centre part of the retaining pin is removed. The outer part of the retaining pin is then able to be driven in further and again the 2.5 mm drill is used to remove more of the pin. Repeated several times the outer part of the pin will be removed completely. A 5/64 inch drill is then inserted into the hole left by the top part of the pin so that the remainder of the pin can then be drilled out. The check valve which is comprised by the nozzle and ball bearing can then be driven out from the opposite end. The check valve is restored by cleaning the internal ball bearing seat with a drill, replacing the ball bearing with a new one, reinstalling the nozzle and installing a new retaining pin.

The method of removal of the check valves follows. The check valves are held in place by a retaining pin and it was apparent that it would be extremely difficult to drill this pin out accurately. The exit opening of the check valve
